ICELANDIC MARITIME ADMINISTRATION

RISK ASSESSMENT OF FERRY BAKKAFJARA - VESTMANNAEYJAR

REPORT No. 2161-2006

DET NORSKE VERITAS

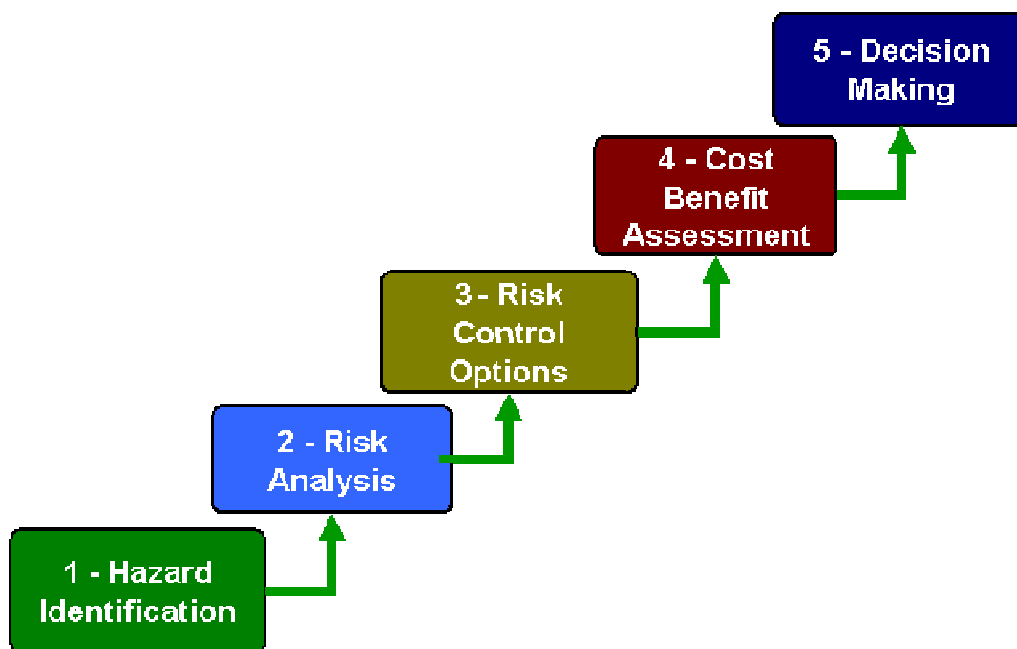
Figure 1 Risk assessment main steps

The risk assessment process follows the FSA (Formal Safety Assessment) main stages as recommended by IMO. This is illustrated in Figure 1.
